SERVICE INFORMATION

Vol. 1 No. 1

LAND-ROVER PETROL AND DIESEL MODELS

The Rover Company Limited, Solihull,
Warwickshire, England

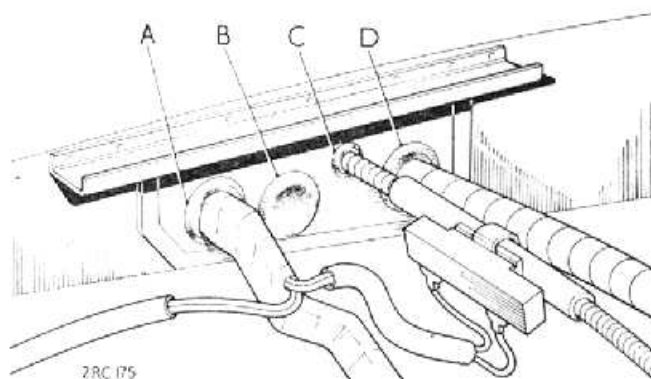
Some early Series III vehicles have the speedometer cable routed through the grommet hole which is normally blanked off. This incorrect assembly forces the cable through a sharp angle and can promote early speedometer inner cable failure.

Fig. 2 Correct location of speedometer cable RH Stg. models

- A—Main body harness
- B—Grommet for blanked off aperture
- C—Choke cable
- D—Speedometer cable

Service Personnel should familiarise themselves with the correct layout as illustrated and give particular attention to this point when early Series III Land Rovers are inspected.

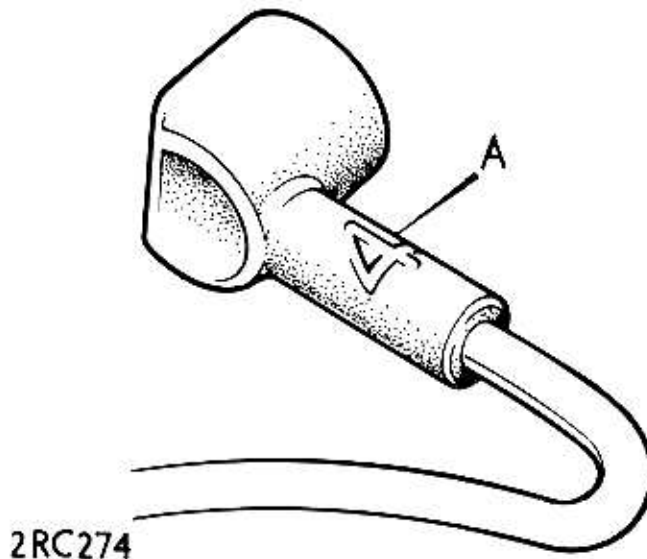
REMARKS: Several cases of engine misfire, and poor starting under wet or damp conditions have been reported and investigation has shown this to be caused by poor moulding of the right angled coil boot on the coil to distributor high tension ignition lead.

**Fig. 2 Identification of ignition lead**

A—Moulding number

If this condition is detected or brought to your attention by an owner, on vehicles sold during the last 12 months, then the coil to ignition lead must be changed for the modified type, which has a moulding number stamped on the right angled coil boot. The earlier type has no moulding number.

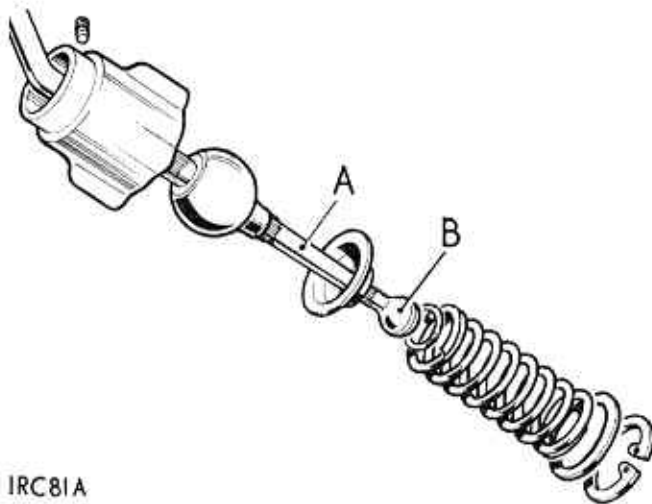
IRC81A

Over a period of time there have been instances of failure of the Polyurethane material used for the ball end attached to the gear lever on Series IIA vehicles.

Fig. 1 Gear lever assembly

Any future recurrence of this problem should be satisfactorily remedied by fitting a replacement gear lever.

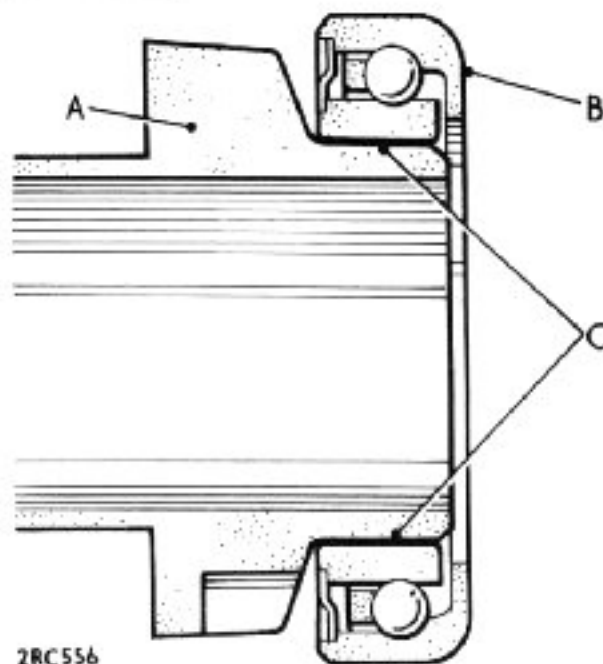
The above modification has been introduced to reduce the possibility of the clutch release sleeve becoming seized on the front cover extension during arduous driving conditions and to improve the bearing lubrication.

The assembly comprises a sleeve manufactured from 'Ferrobestos' and a new release bearing which is packed with grease and sealed. These are bonded together by Loctite high strength retaining compound.

**Fig. 2 Clutch release bearing and sleeve assembly**A—'Ferrobestos' sleeve
B—Sealed bearing
C—'Loctite' bonded joint

The assembly is interchangeable with the earlier bearing and sleeve but is only available as a complete assembly.

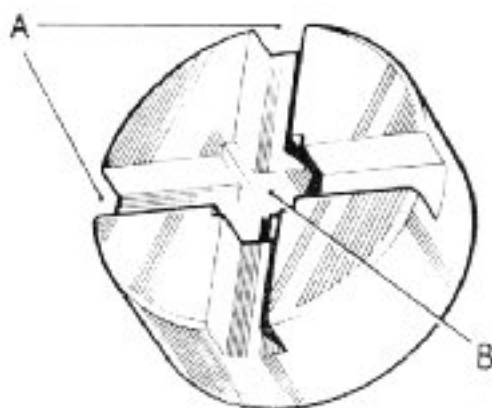
2RC 322

Item 47**SUBJECT: SERVICE TOOL FOR GEARBOX MAINSHAFT NUT****MODELS:** All Land-Rover.**MODIFICATION:** Introduction of a torque spanner adaptor for use with the existing box spanner, Part No. 600300, for the gearbox mainshaft nut.**LITERATURE AFFECTED:** Land-Rover Series II and IIA Workshop Manual, English, Part No. 606407, Operation C1-22.
Land-Rover Series III Repair Operation Manual, English, Part No. 607314, Operation 37.20.25.**PART NUMBER:** Torque spanner adaptor for mainshaft nut spanner 1 RO 1013**REMARKS:** The current gearbox build specification requires the special nut Part No. 217477 at the transfer gear end of the gearbox mainshaft to be tightened to 12,5 kgf.m (90 lbf.ft.) prior to turning up the lockwasher. The above listed adaptor is now available for this purpose and is designed to fit on the end of the existing mainshaft nut spanner Part No. 600300. It is recommended that this torque loading be applied on earlier, as well as later, gearboxes during the applicable overhaul procedure.

Fig. 2 Torque spanner adaptor RO 1013 for mainshaft nut spanner
